## 2022 Annual Report

# 1. Introduction

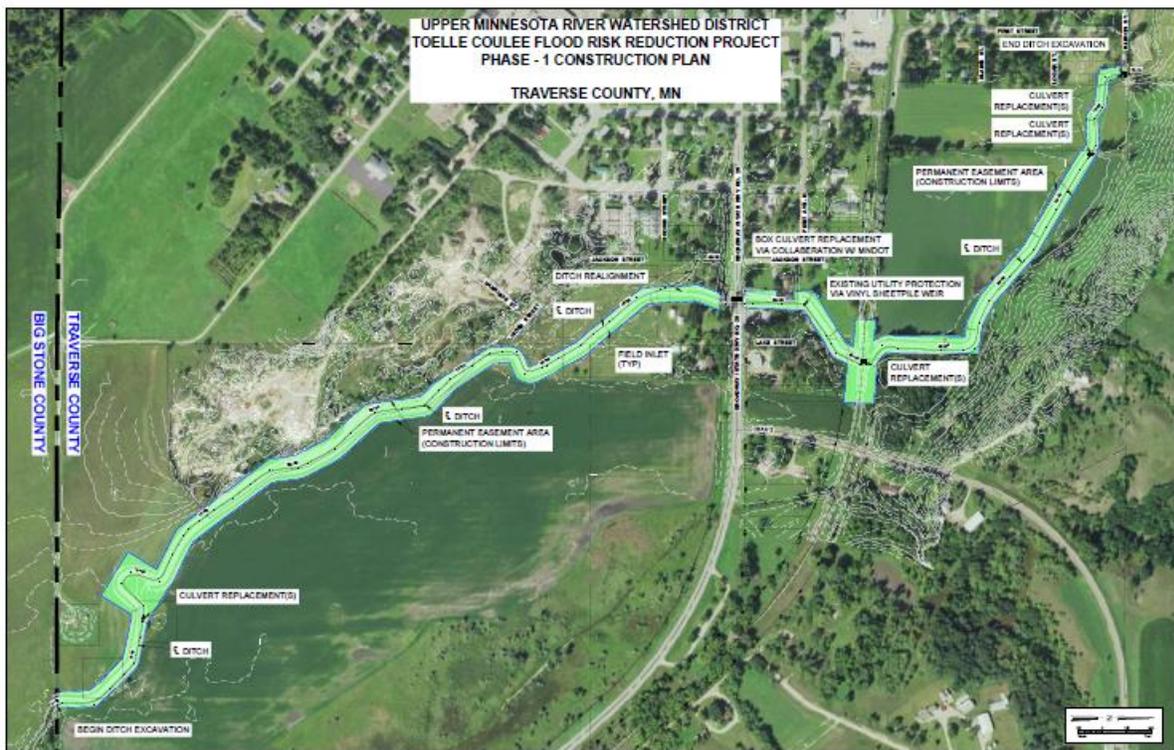
The goal of the Toelle Coulee Project – Flood Damage Reduction is to provide 100-year flood protection to the rural community of Browns Valley. There are five elements to the Toelle Coulee Project, Phase I consisted of the west ditch improvements and was completed in 2020 and inspections were completed in 2021. Routine maintenance checks to track volunteer tree growth were completed.

Funding is still needed for constructing Phase II which consists of constructing the Reinart-Appel Levee, the East Levee, County State Aid Hwy 2 culvert replacement and the Trunk Highway 28 culvert replacement.

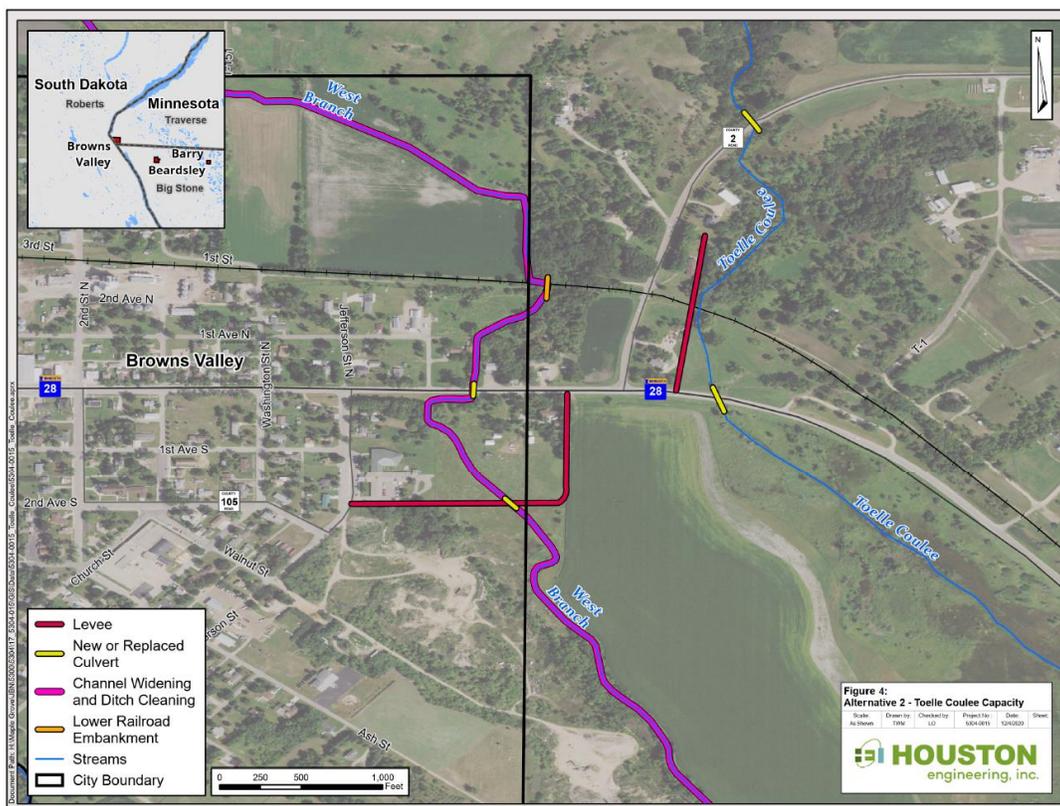
The 2008 Houston Engineering, engineer's report recommended Alternative 2 (**Toelle Coulee Capacity**) and they continue to recommend implantation of that alternative. See Figure Below The District continues to seek funding through the state's Flood Hazard Mitigation Program to complete this project.

1. **Overflow Capacity West of CSAH 2:** This alternative would provide for a lowered and larger capacity overflow channel to the west side of CSAH 2. This alternative will include levees to ensure that floodwaters for the 100-year rainfall event stay within the overflow channel.
2. **Toelle Coulee Capacity:** This alternative would increase capacity of the Toelle Coulee culvert under CSAH 2 and TH28. The alternative would provide a levee between the homes east of CSAH 2 and Toelle Coulee. This alternative also includes a levee south of State Trunk Highway (TH) 28 to prevent Toelle Coulee from backing up into adjacent homes.
3. **Toelle Coulee Impoundment:** This alternative will impound Toelle Coulee upstream of CSAH 2 to prevent the overflow of peak flood waters to the west side of CSAH 2 and decrease the peak flows in Toelle Coulee downstream of CSAH 2.

All three alternatives also require improvements to the West Branch, including channel widening, a larger capacity TH 28 culvert, and a lowered embankment at the railroad crossing. Each of these solutions will decrease the frequency of flooding at the east side of the City of Browns Valley and decrease the likelihood of damage to public infrastructure such as the TH 28 roadway. Each alternative would result in approximately 80 acres removed from the 100-year floodplain north of TH 28.

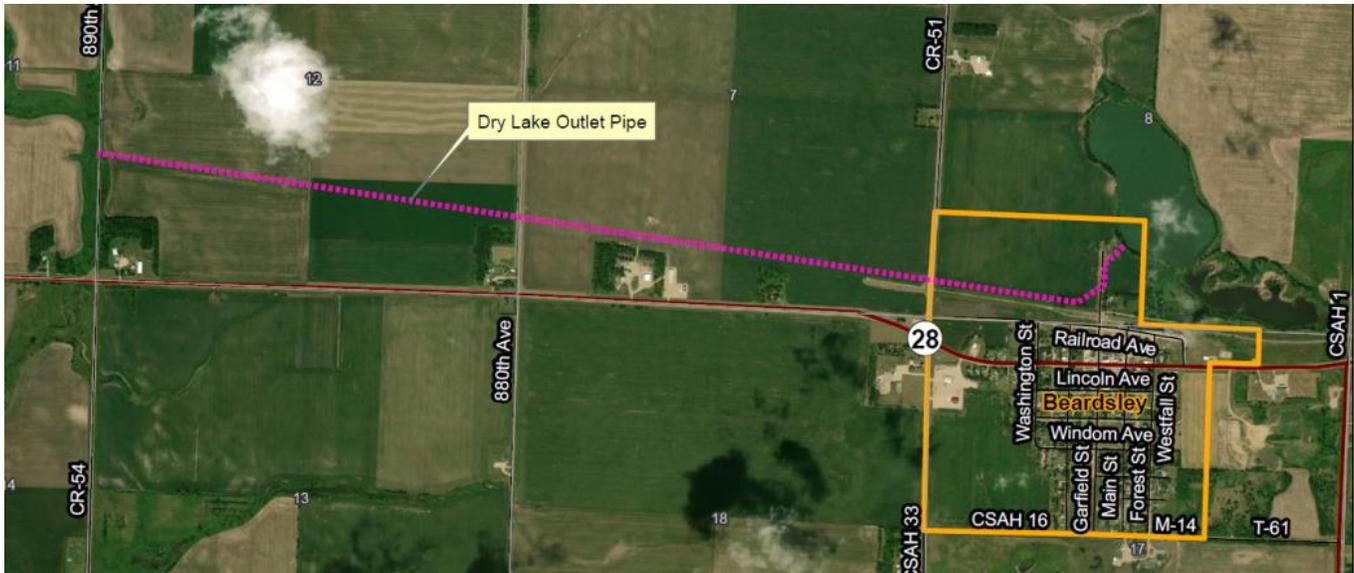
In summer of 1997 crews constructed a 2.6 mile, 36" reinforced concrete pipe, drain line with maximum depths of 28 feet to drain the excess water out of Dry Lake and provide a long-term outlet for Dry Lake to protect Beardsley from future flooding.

The pipe has since experienced seepage, sinking, and erosion issues resulting in a sinkhole forming during the summer of 2019. The sinkhole was temporarily repaired by removing approximately 80 feet of pipe and cutting back side slopes, then in 2020 the open areas were replaced with 36" HDPE and closed.

The UMRWD contracted with Johnson Jet-Line Sewer Cleaning & Pipe Inspection to perform televising of the 2.6-mile-long pipe in the summer and fall of 2019/ early 2020. The pipe was accessed using the existing manholes in 14 segments. Some segments of the pipe were not televised due to either grade, sediment, or complications with backwater.

**Cracking:** Some segments of the pipe exhibit multiple transverse cracks and longitudinal cracks. Not all cracks require repair, rehabilitation or replacement. However, longitudinal cracks can be an indicator that the steel has taken a portion of the loading.

**Cracking or sprawling** that has reached a point of exposed reinforcement, is a candidate for repair, depending on severity of the cracking and the soil conditions, i.e. corrosivity of the water. Exposed reinforcement was observed in one location and exposed aggregate was observed in several locations. Feasibility of reusing and rebedding the cracked pipe segments cannot full be known until the pipe is exposed.

**Pipe Settlement / Pipe Grade Issues:** Significant portions of the pipe appear to have settled unevenly or been placed an improper grade, as indicated by standing water in the pipe (including locations televised under water or not televised at all). Sediment or other blockages may contribute to some of these standing water levels. However, it is likely most of these segments have flat or negative grades. These grade issues may be from initial construction or settling over time

**Infiltration and Joint Issues:** Several portions of the pipe have prevalent infiltration or joint offset issues. Records from construction are unavailable but given the extent of infiltration it is likely the joints were not wrapped. This, combined with pipe separation due to settling, allows adjacent sediment to enter the pipe, which creates a cavity. These cavities and infiltration issues are likely contributing to the other observed issues, such as settling and cracking.

**Sediment and Blockages:** Likely related to the infiltration and joint issues, there are several locations where sediment or blockages were observed in the pipe. In one instance, sediment caused the televising to be abandoned. Some blockages appear to be caused by roots growing into the pipe joint, and/or debris entering from the lake outlet structure.

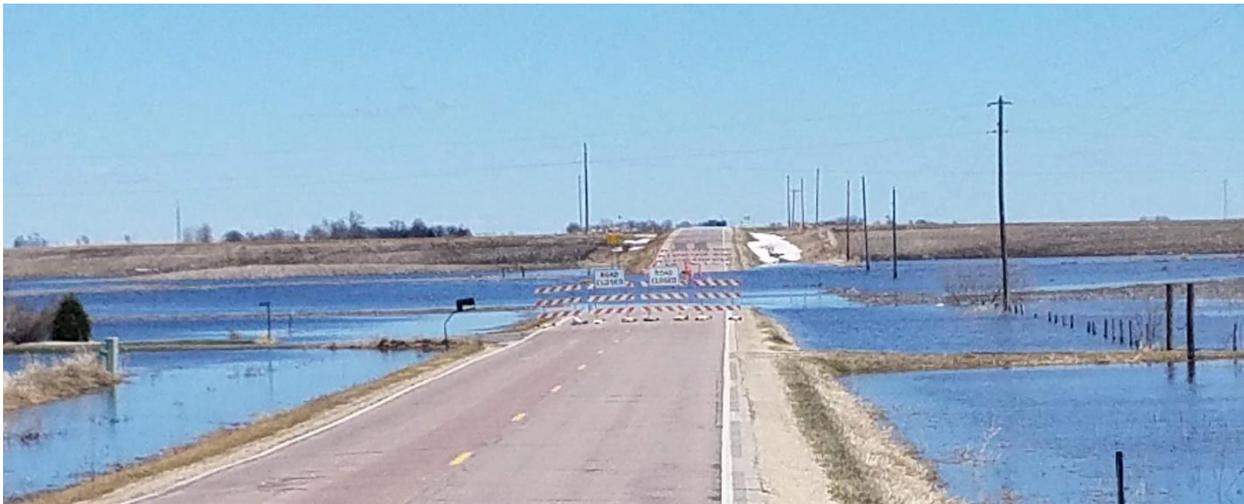
In 2011 a multi-phase project was completed to add an additional outlet, which consisted of 2600 LF of new 18-inch dual wall polyethylene tile and 950 feet of new open channel.

In the spring of 2019, Highway 12 was inundated for over 3 weeks, resulting in the adjacent landowners requesting the Upper Minnesota River Watershed District to evaluate potential solutions in conjunction with an upcoming MnDOT highway improvement project. MnDOT made revisions to their original plan and the highway improvement project was completed in 2021, replacing a 30-inch corrugated metal pipe (CMP) with a 42-inch reinforced concrete pipe (RCP) with flared end sections.

The project also raised the overtopping elevation of the road from 1090.2 to 1093.6 (Station 96+00)
